Safety Check PEANUT I and Y

We have become aware of a potential error in the manufacturing process of our products **PEANUT I** and **PEANUT Y**. For your own safety, we ask you to please check all the products in your possession. We want to avoid the use of a faulty product in all instances, as this could potentially result in severe damage/s.

On inspection of a PEANUT device, we noticed that a rivet had not been properly processed during manufacture. In use, this could cause loosening of the connecting piece between the device and the shock-absorbing element. In order to avoid the unintentional use of a potentially faulty device, we urgently ask you to check your PEANUT device/s as described below.

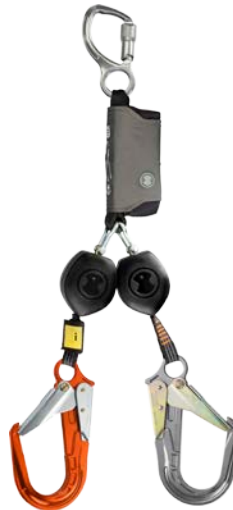
PEANUT I
Art. No.:
HSG-021-...
HSG-AUS-021-...

All carabiner versions (not only those models depicted here) may be affected.
Please note that PEANUT products are also components of configured **sets**.

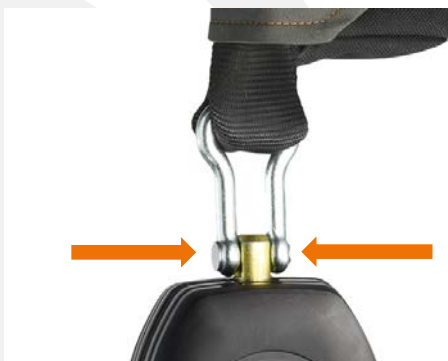
Abb. 1

1. Please check the connecting piece between the black plastic housing and the shock-absorbing element (**see figure 1**). Verify that the pin and the shackle are properly riveted (**see figure 2**). The riveting has to end evenly on both sides.
2. Take the device near the connecting piece, jolt and turn the device in both directions (**see figures 3a and 3b**). The rivet must not loosen.
3. Push the rivet from both sides with a stable object (e.g. screwdriver) (**see figures 4a and 4b**). By doing that, the rivet should not move. If the rivet moves or if it is not properly connected to the shackle (**see figures 5a and 5b**), the product must not be used.
4. For good measure, compare the riveting with the **figures 6a and 6b**.
