CORROSION OF METALS IN ROPE ACCESS

Dr Chris Robbins

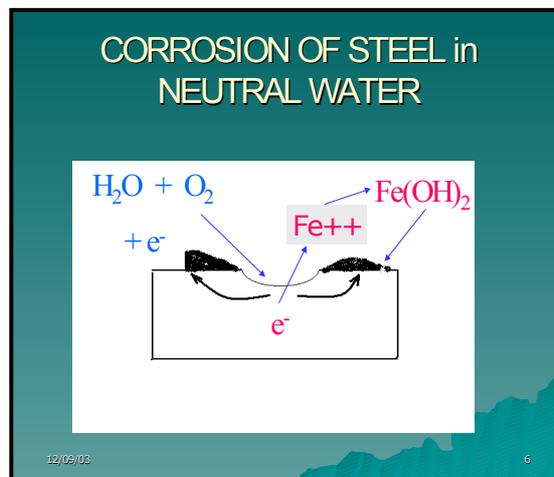
Figure 6

An example of the above is corrosion of steel. As iron corrodes in neutral waters the electrons produced feed the cathodic reaction between water and oxygen, generating OH^- ions. This leads to the formation of iron hydroxides that later will give the familiar rusts of Fe_2O_3 and Fe_3O_4 . It may be noted that an excess of OH^- ions would oppose this particular cathodic reaction and this explains why steels corrode less in high pH alkaline conditions than in neutral or acid conditions.

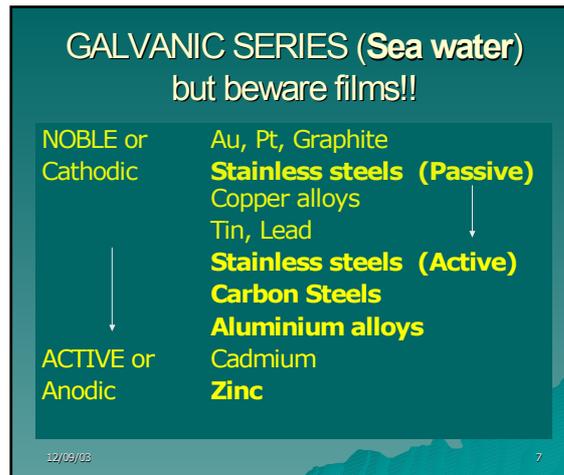
Figure 7

Another concept, also based on the anode/cathode reaction pair above, is that of the **galvanic series**. Any metal immersed in a solution of its own salts will attain a set potential, and always the same potential (for set conditions) - the Standard Electrode Potential. (e.g. Hydrogen = 0 volts, Au = +1.5 V, Fe = -0.44 V etc). When any two different metals are connected together in electrolytes, current will flow as a result of the difference in the potentials of the two metals. This will result in corrosion of the metal at the lower potential, and, conversely, protection of the metal at the higher potential.

A practical variation is to use a common electrolyte, seawater usually, and to include alloys in the list of potentials so obtained. This is the **Galvanic Series**. It is often presented simply as a list of metals and alloys arranged in the order of their potentials with more noble at one end and least noble (and more easily corroded) at the other. If any two different metals are connected together then the list will suggest which of the two will corrode preferentially. Additionally, the further apart two metals are in the list, the greater the driving force for corrosion of the more anodic metal.

Some points to note:

- Stainless steels appear high up the table towards the 'noble' end. This is due to the protection given by a very thin film of chromium oxide when in its passive condition. Should this film not form or be damaged and not repair, then stainless steels will behave similarly to carbon steels in those localities – hence the dual positions in the table.

- Thin oxide films forming on aluminium alloys also are protective, partly by acting as an electrical insulator and preventing or impeding direct contact with other metals. However, as with stainless steel, the film is not always protective and localised breakdown would lead to rapid corrosion particularly in a galvanic or crevice situation.

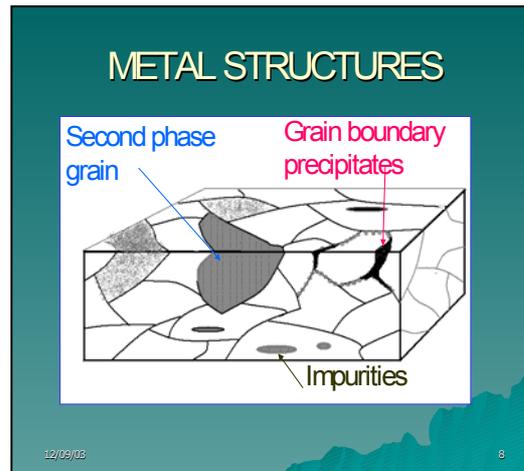
Figure 8

A brief examination of metal surfaces is needed before considering the various types of corrosion that can afflict rope access equipment. Metals consist of grains; each grain is attached to its neighbours. Not all grains have the same structure and this is particularly the case in many alloys. A grain that differs from its neighbours (second phase) may have a different position in the galvanic table and this can lead to highly localised anode/cathode cells developing on the surface.

At boundaries between grains, precipitates can form during, for example, heat treatment and welding. These precipitates inevitably have a different structure to the surrounding bulk metal and may be the cause of similar localised corrosion processes. The presence of impurities, trapped during the melting, casting and forging operations, may also trigger corrosion locally, again resulting from the proximity of anodic and cathodic sites.

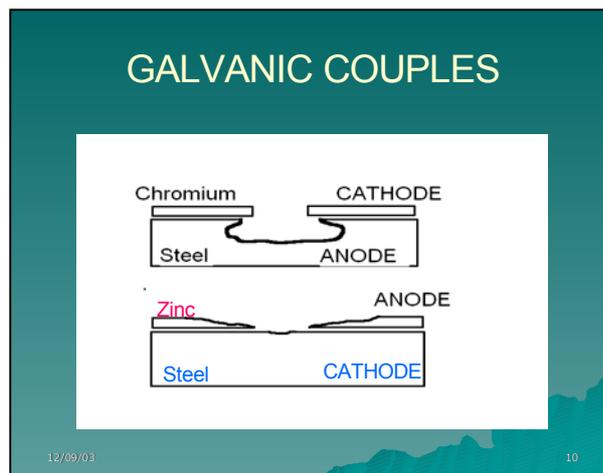
Figure 10

This occurs when two different metals are connected together and have a conducting solution present. Inevitably, one of the metals will be more noble than the other. The more 'different' the metals are electrochemically, the greater will be the tendency for the least noble to corrode. Steel pins in aluminium bodies, chromium plate on steel buckles and zinc protection of steel wire are examples.

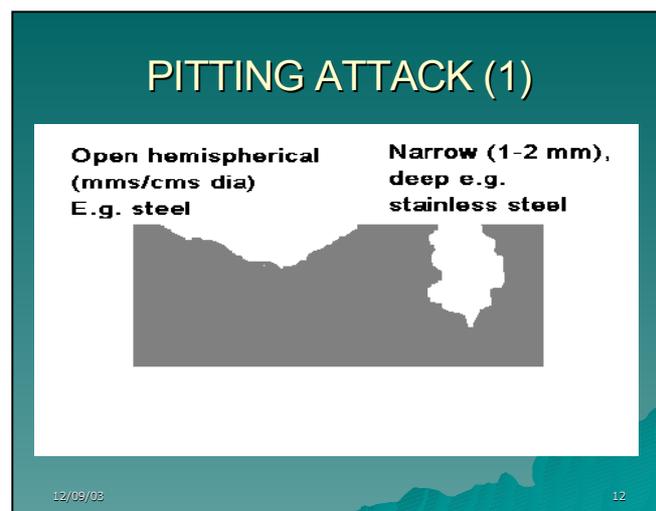
Figure 12

Pit shapes vary; shallow dish shaped pits or more severely damaged areas often occur on steels (sometimes initiated beneath rust or oxide/slag). Stainless steels frequently have small 1-2 mm

diameter deep pits perhaps 2 mm deep. Aluminium may exhibit several forms but, because attack tends to be intergranular, pits are often small and steep sided. Pit sites frequently have nodules or mounds of deposit sitting on top.

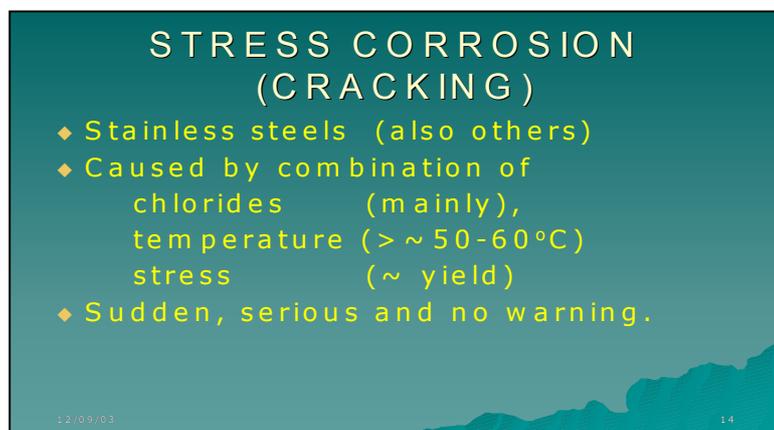
Figure 14

The problem of stress corrosion cracking in stainless steels is unlikely to afflict rope access workers under normal conditions, which is just as well as it can occur suddenly and catastrophically! The requirements for stress corrosion cracking in stainless steel are:
